'Wildlife-friendly' fencing is not friendly to Kalahari antelopes

Derek Keeping^{1*}, Horekwe (Karohe) Langwane², Njoxlau Kashe³

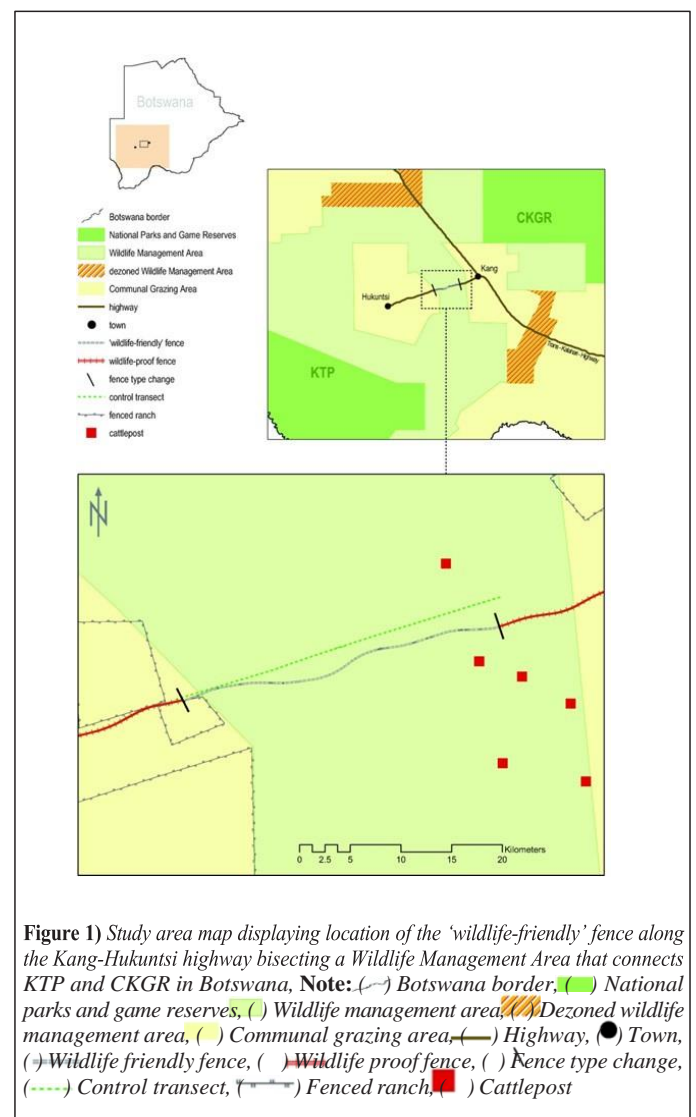
Figure 1 Study area map displaying location of the 'wildlife-friendly' fence along the Kang-Hukuntsi highway bisecting a Wildlife Management Area that connects KTP and CKGR in Botswana. **Note:** (---) Botswana border, (■) National parks and game reserves, (■) Wildlife management area, (■) De-zoned wildlife management area, (■) Communal grazing area, (—) Highway, (●) Town, (---) Wildlife friendly fence, (—) Wildlife proof fence, (—) Fence type change, (---) Control transect, (—) Fenced ranch, (■) Cattlepost

The Kang-Hukuntsi highway is a 108 km-long paved road that branches off the Trans-Kalahari highway in Botswana. It connects the two largest towns (Kang and Hukuntsi) in between Central Kalahari Game Reserve (CKGR) and Kgalagadi Transfrontier Park (KTP) (Figure 1). The road bisects communal grazing areas mostly, but also a section of Wildlife Management Area (WMA) that is generally appreciated to be a wildlife movement corridor ultimately connecting KTP and CKGR [9-10]. Prior to 2011, a fatal traffic accident mobilized local constituents to advocate for complete fencing along both sides of the road. Discussions between Botswana's Roads and Wildlife Departments led to a compromise: an experimental 'wildlife-friendly' fence design [11] would be erected through the WMA, and a wildlife-proof fence erected along the remainder of the highway. The 'wildlife-friendly' design is intended to block livestock from accessing the road but remain permeable to wild antelopes. The fences were completed in 2011. Since then, no follow-up monitoring has been conducted.

The 'wildlife-friendly' fence between Kang and Hukuntsi spans 31.5 km. It does not extend completely across the WMA through which the highway passes, perhaps because several cattleposts have encroached into the eastern part of the WMA resulting in high livestock numbers there (Figure 1). The fence is comprised of three equally spaced barbed wires, the top wire 80 cm above ground level, although varying in height with micro-topography. Both sides of the highway right-of-way are fenced, 60 metres apart. The 'wildlife-friendly' fence ends where it ties into a wildlife-proof fence comprised of 125 cm high page wire plus a single barbed wire above at height 140 cm (Figure 2). The wildlife-proof fence continues along both sides of the highway east and west to Kang and Hukuntsi respectively. Directly north of the Kang-Hukuntsi highway at a varying distance of 120 m to 2.7 km lies the old Kang-Hukuntsi Road. It is a straight narrow sand track that no longer receives traffic. This linear feature conveniently served as a control transect paralleling the 'wildlife-friendly' fence (Figure 1).

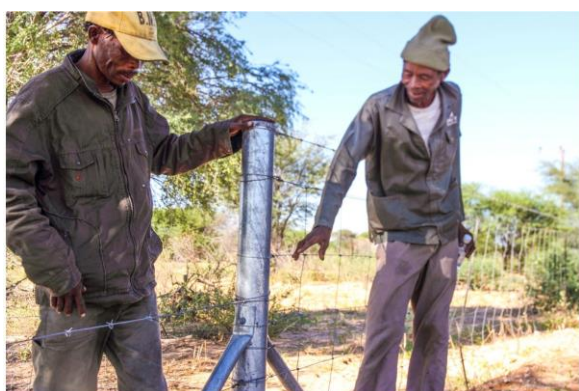
Figure 2) Relative height of the top barbed wire of the 'wildlife-friendly' fence (left) where it ties into the wildlife-proof fence (right)

Along its 31.5 km length, the 'wildlife-friendly' fence is mostly intact, with a lesser proportion of sections that are damaged, although we did not quantify these linear proportions. For both hartebeest and gemsbok, the mean fence height at which animals voluntarily (as opposed to being frightened by traffic and running blindly towards the fence) made successful crossings was 61 cm, while the mean fence height where animals deflected was 74 cm. Of voluntary hartebeest crossings, 55% occurred where the fence was damaged (i.e., the highest barbed wire was lower than 70 cm), while only 12% of deflections occurred at damaged sections. Of voluntary gemsbok crossings, 80% occurred where the fence was damaged, while 25% of deflections occurred at damaged sections.

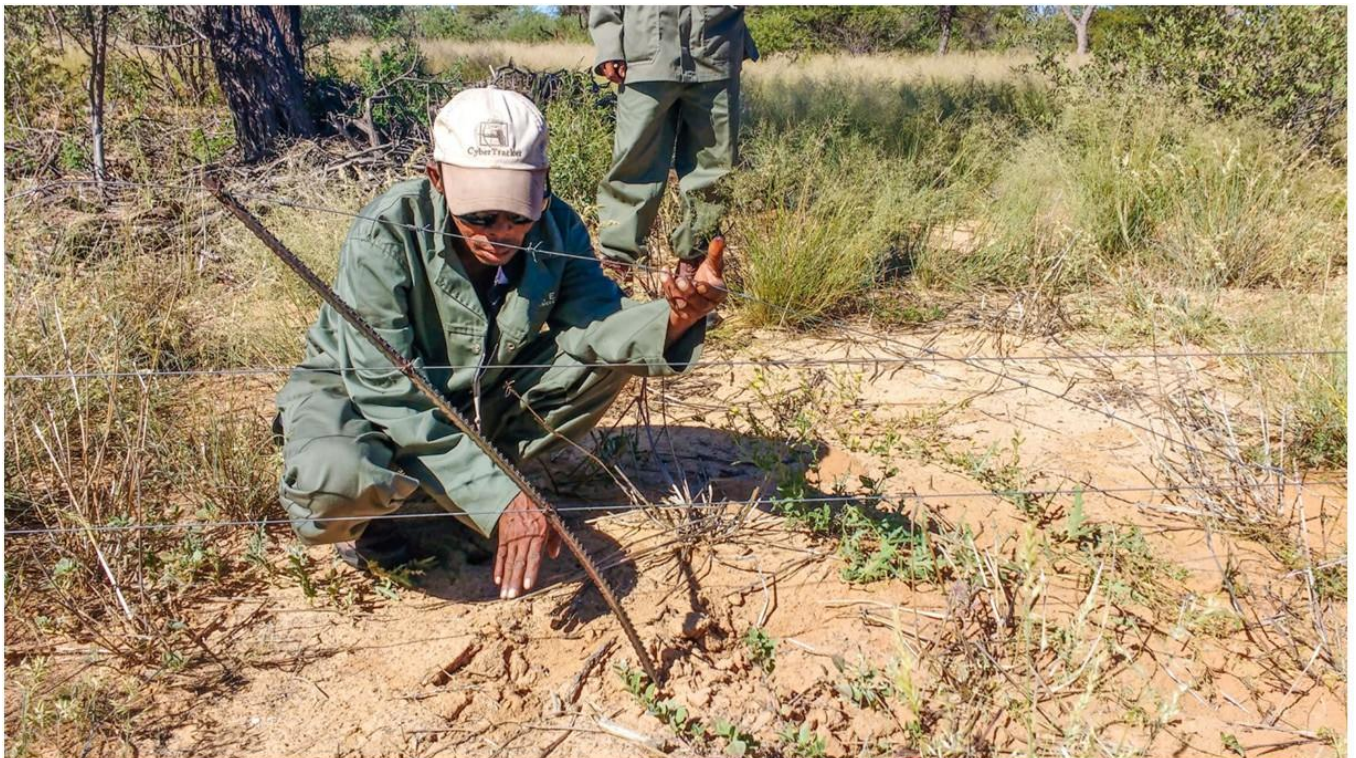
- A gemsbok approached the fence and road from the south at a walk. It became entangled in the fence wires, bent a metal dropper during the struggle (Figure 3), then ran back south, failing to cross the fence.
- A large bull gemsbok was startled by traffic and ran south from the highway towards the fence. Head down, it smashed into a sturdy stabilizing fence post, breaking its neck as its body flipped over the wires onto the other side of the fence (Figure 4).

Figure 3) Master Tracker HL indicating where a gemsbok contacted the 'wildlife-friendly' fence, bending the metal dropper and damaging the top wire

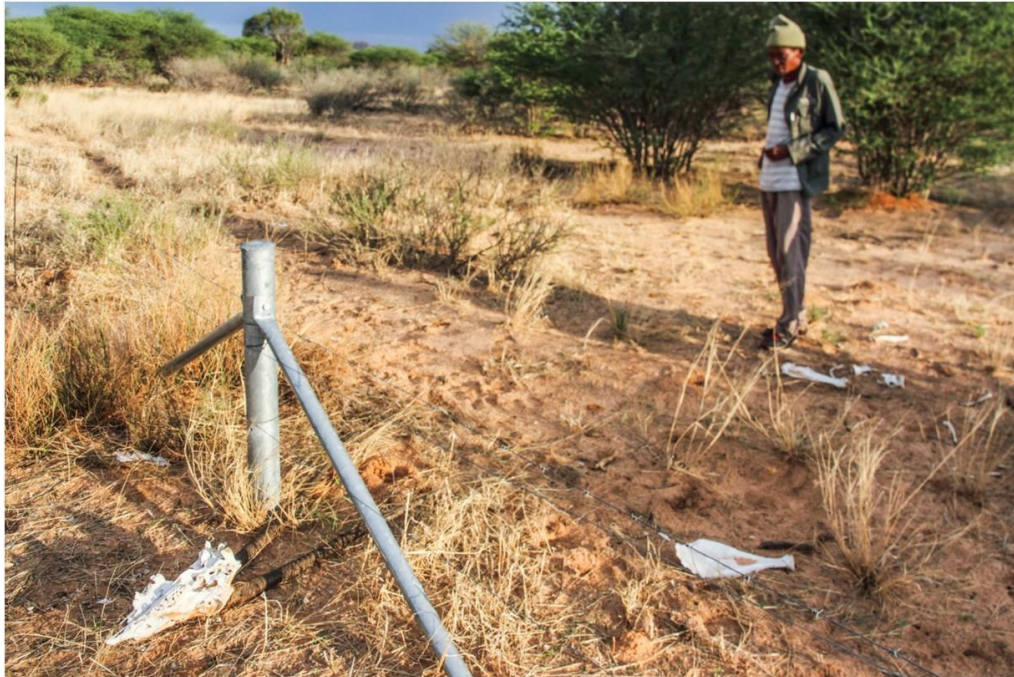
Figure 4) *Remains of a gemsbok killed upon impact with a stabilizing fence post along the 'wildlife-friendly' fence*

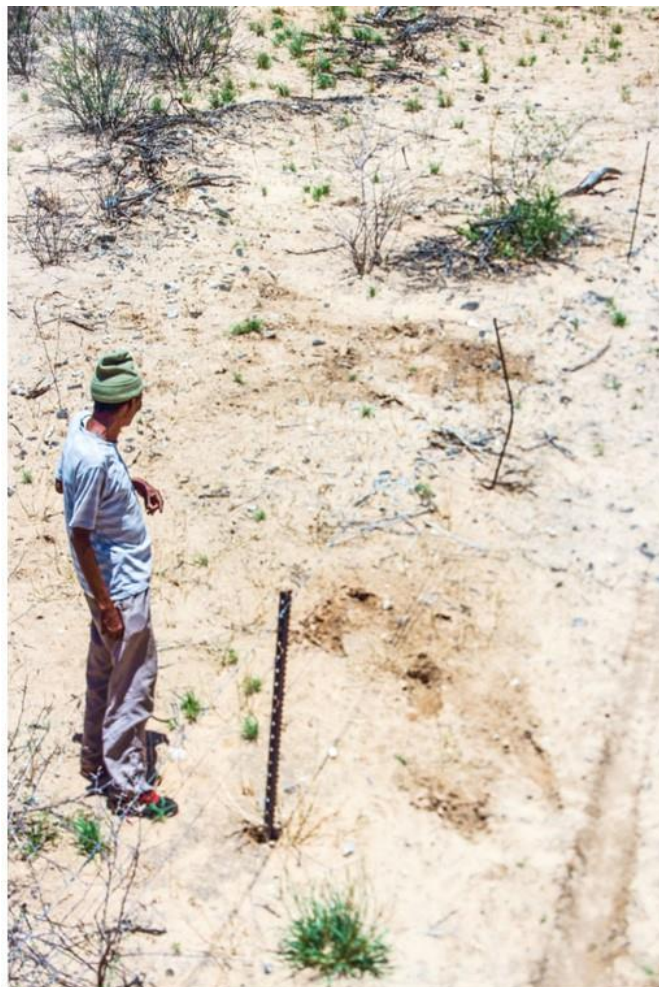
- A hartebeest was frightened by a vehicle and sped in a gallop towards the fence at an oblique angle. It attempted to brake and deflect just before contact at a particularly high point (98 cm), bent a metal dropper, left hair on the top barbs as it went over, and whilst airborne spun 180 degrees, landing on its side with horn digging into the sand (Figure 5). It recovered and continued southwards.

Figure 5) *Master Tracker NK showing where a hartebeest contacted the 'wildlife-friendly' fence at a fast gallop, bending a metal dropper and falling turned 180 degrees on the other side*

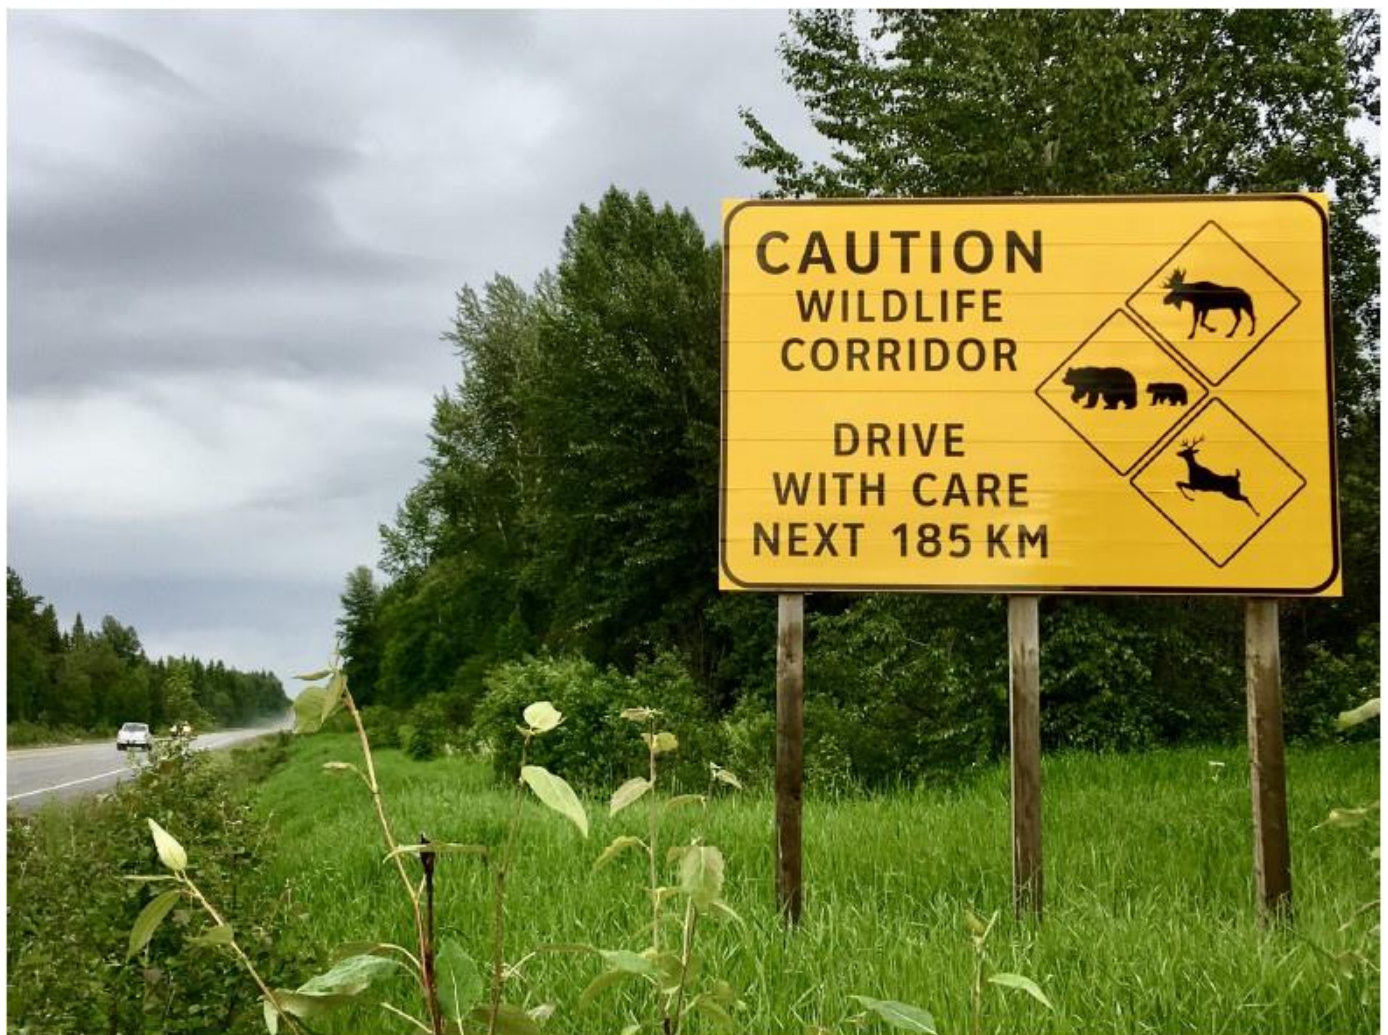
Figure 6) Example signage to affect motorist behaviour where unfenced highways bisect major wildlife travel corridors. British Columbia, Canada

Spatial threats to wildlife at this narrowed corridor are substantial without the additional stress of the 'wildlife-friendly' fence. Our data show that this area remains an active wildlife movement corridor. We also show that the 'wildlife-friendly' fence fails its mitigation purpose to allow unhindered wildlife movements through the WMA, whilst also failing its primary purpose of keeping livestock off the highway. We therefore recommend that the 'wildlife-friendly' fence be deactivated, and all fencing materials be removed as even downed wires pose an entanglement hazard to wildlife. In addition to fence removal, cattle grids could be installed over the highway at both tie-ins with the wildlife-proof fence (consistent with the design used at other wildlife corridor areas along the Trans-Kalahari highway) to limit livestock movement into the high-fence right-of-way. This could be done in combination with enhanced signage that educates motorists and encourages safer driver behavior (Figure 6). Although in practice all fence types fail to keep Kalahari highways livestock-free, there is even less reason to fence sections that bisect WMAs which have the least livestock numbers and pose the least risk of collisions.
